# PROJECT SHORL

STRUCTURAL SURVEY OF PRIVATE MINING PROPERTIES

U.S. BUREAU OF MINES

# STRUCTURAL SURVEY OF PRIVATE MINING PROPERTIES

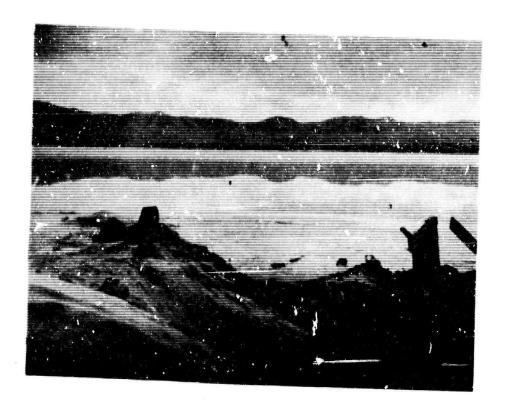
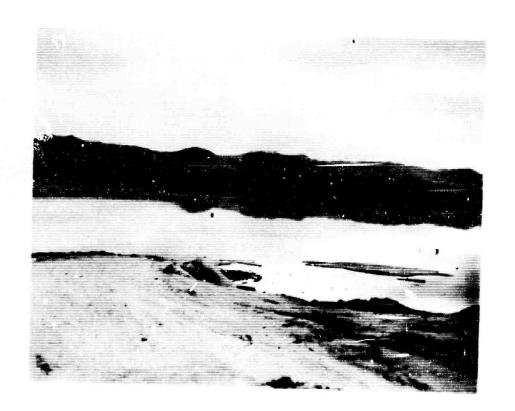
Photo 1-1-1. Preshot. September 30, 1963

Photo No. 1-1-1. At central salt pile looking southeast across the settling salt pond toward surface zero about six miles distant. A heavy rain occurred between the pre- and postshot surveys, raising the water level.

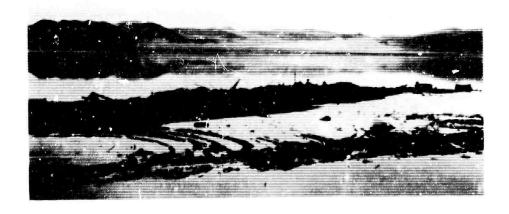
Photo 1-2-2. Preshot. September 30, 1963.

Photo No. 1-2-2. Northeast across the salt pond and toward the north end of the Sand Springs Range.

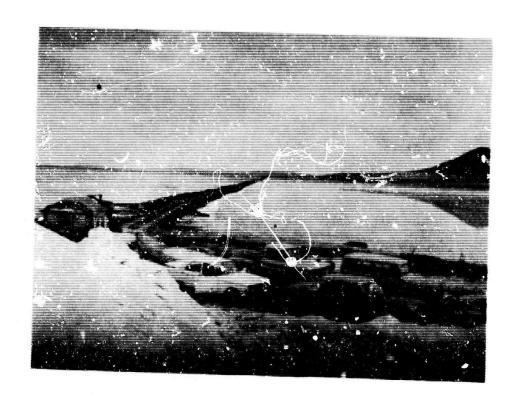
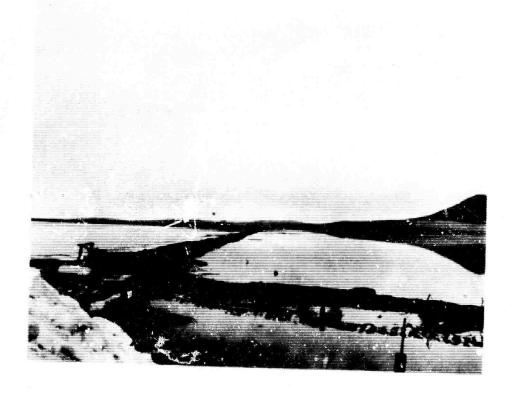
Photo 1-3-3. Preshot. September 30, 1963.

Photo No. 1-3-3. Northwest along the access road and northern portion of the salt pond.

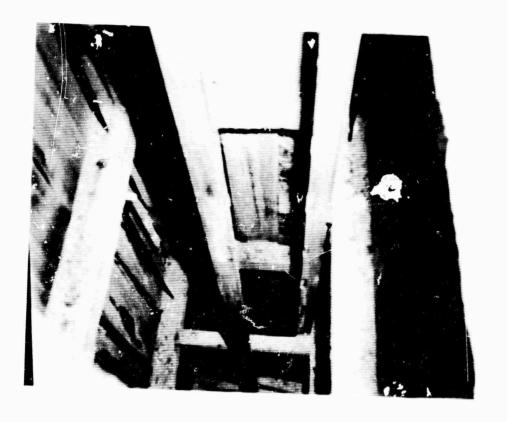
Photo 2-1-4. Preshot. September 30, 1963.

Photo No. 2-1-4. North two-compartment vertical shaft. Some lagging gone, no partition with manway. Timbered dimensions are  $6 \times 4$  feet. This shaft is reportedly 225 feet deep, but is blocked with debris and water at an estimated 50 feet.

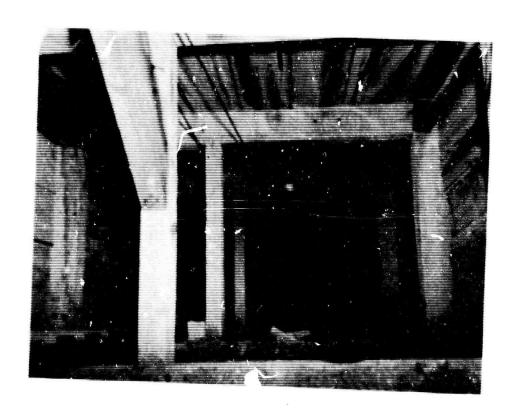
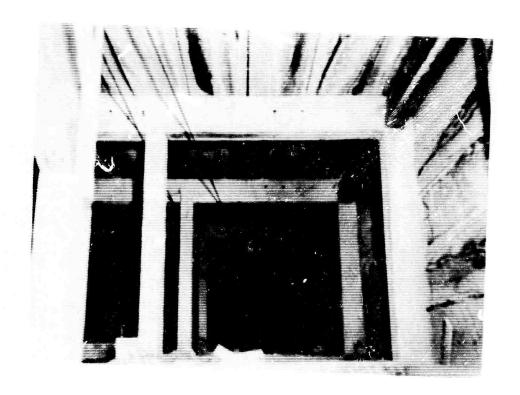
Photo 2-4-7. Preshot. September 30, 1963.

Photo No. 2-4-7. Southwest two-compartment shaft inclined at 60 degrees. Sets, lagging, and ladder in place. No partition with manway, nor cage guides. Timbered dimensions are 9 x 6 feet. Reportedly about 200 feet long.

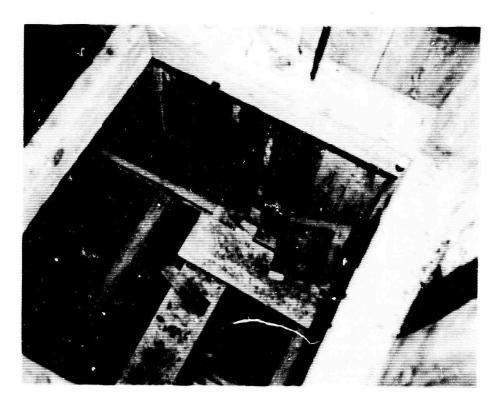
Photo 2-5-8. Preshot. September 30, 1963.

Photo No. 2-5-8. Northwest two-compartment vertical shaft, reportedly 250 feet deep. Lagging, sets, and ladders with landings every two sets in place. No partition with manway, nor cage guides on manway side. Timbered dimensions are 10 x 6 feet.

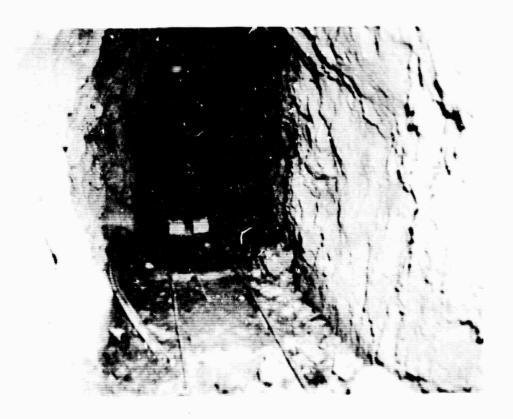
Photo 4-2-12. Preshot. September 30, 1963.

Photo No. 4-2-12. View looking back along 150-foot level development drift toward shaft station. Miscellaneous equipment scattered along drift.

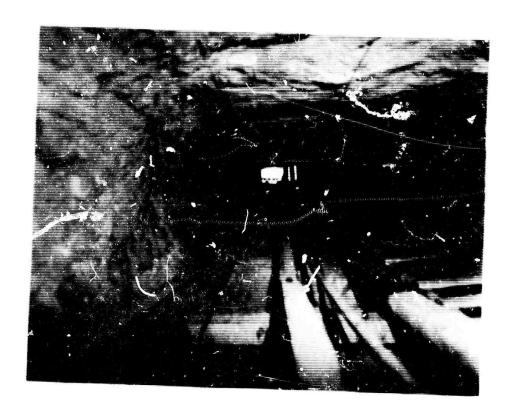
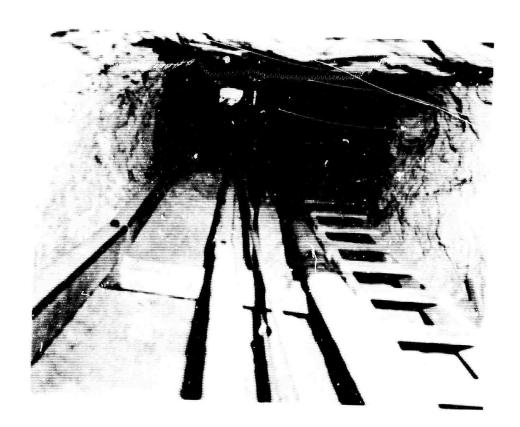
Photo 4-5-15. Preshot. September 30, 1963.

Photo No. 4-5-15. At the 100-foot level shaft station looking upward. The inclination of the upper shaft is 55 degrees to the 100-foot level and 35 degrees to the 150-foot level. No constructed shaft structure but occasional 6 x 6-inch timber stulls are used for support. Rock dimensions are irregular about 8 x 5 feet. Ladderway, bucket guides, ventilation pipe and air line in place.

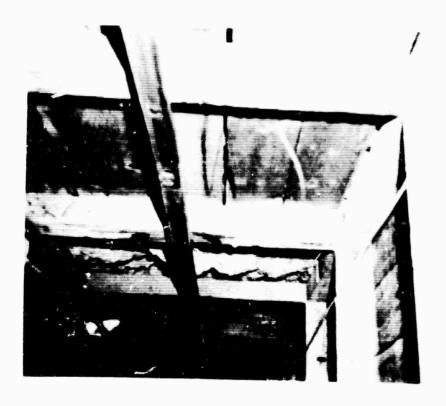
Photo 5-1-18. Preshot. September 30, 1963.

Photo No. 5-1-18. Main vertical shaft. Timbered dimensions are  $7 \times 5$  feet. Reported depth is about 600 feet. Lagging, sets, and cage guides in place. Some sets in good rock have no lagging. One compartment timber construction without manway.

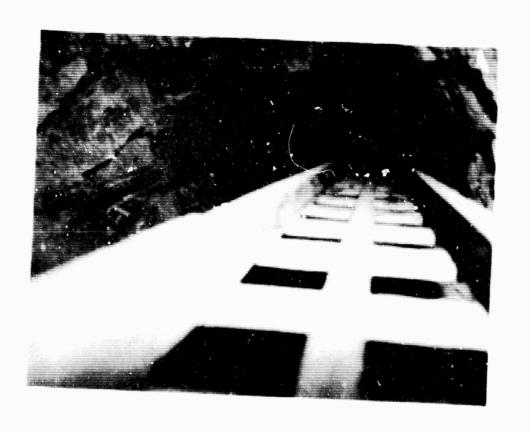
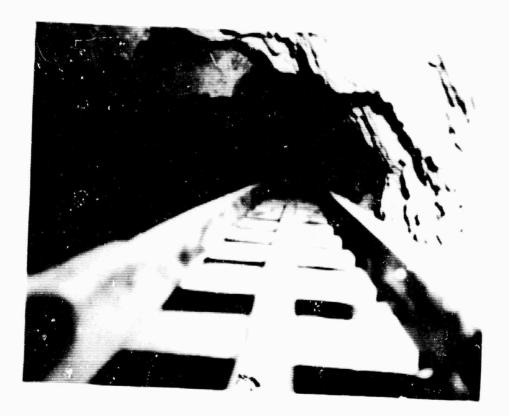
Photo No. 8-7-31. East End Mine exploratory shaft inclined at estimated 45 degrees. Rock dimensions are irregular, about 4 x 4 feet. The shaft is about 40 feet in depth. Except for one timber collar set, the shaft is unsupported. Combination bucket guides and ladder in place.

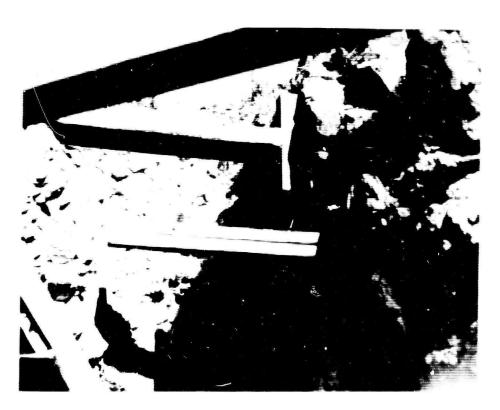
Photo No. 8-8-32. Partially timber supported open stope contiguous with East End shaft at the surface. The open stope is 5 to 8 feet wide and 10 feet deep. Randomly placed stulls of 4 x 4-inch and 6 x 6-inch timber.

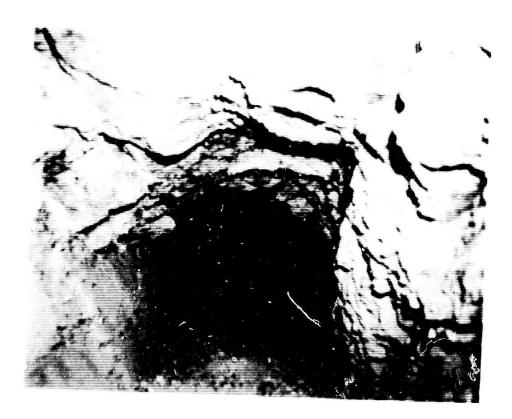
Photo No. 9-1-33. Rock back in exploratory shaft inclined at estimated 30 degrees to the southeast and about 40 feet in length. Rock dimensions are irregular, about 5  $\times$  4 feet. The shaft is entirely unsupported, and the floor is covered with backfill and rubble.

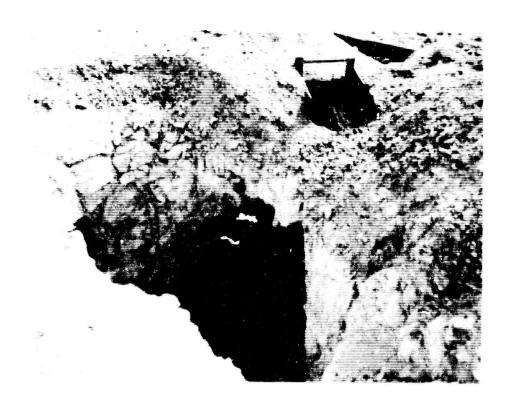
Photo No. 10-1-36. Open stope mined to surface. Irregular width about 6 to 8 feet, and less than 100 feet in depth. Randomly placed timber stulls are used for support. The rock is heavily fractured.

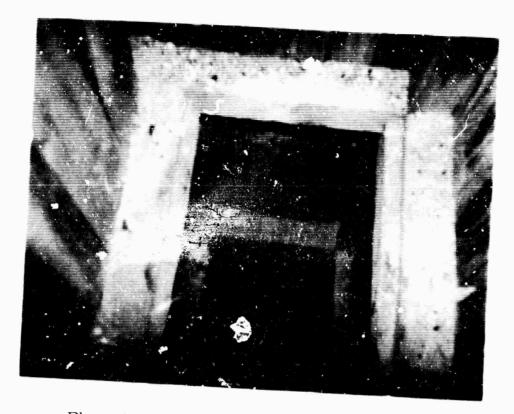
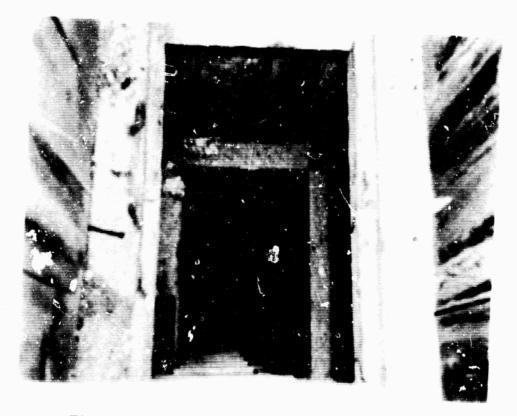
Photo No. 10-4-39. Manway compartment of east vertical shaft. Timbered dimensions are about 5 x 3 feet. Sets and lagging in place but some lagging gone. Manway ladder in place.

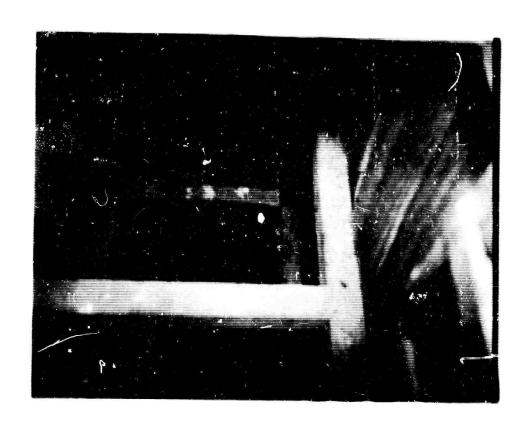
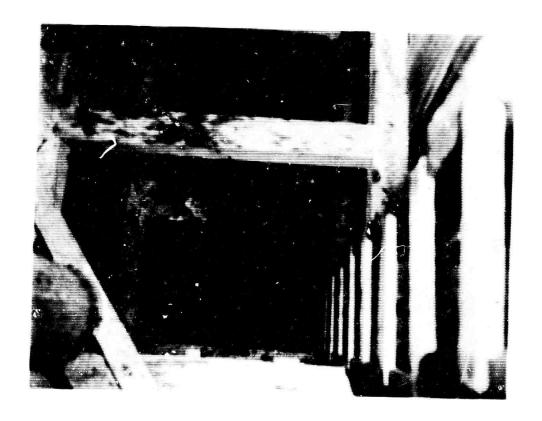
Photo No. 10-7-42. Main vertical two-compartment shaft. Timbered dimensions are about 8 x 5 feet. Reportedly 300 feet in depth. Lagging, sets, and ladder in place. No cage guides or manway partition.

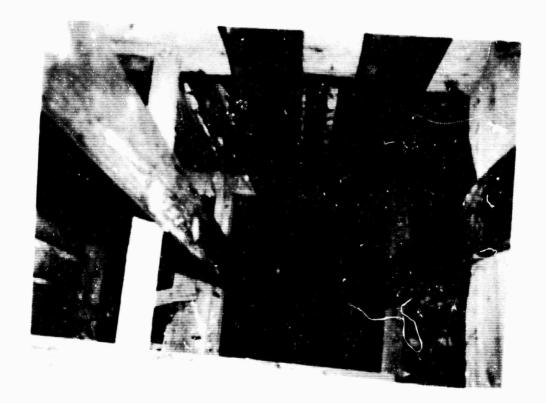
Photo No. 10-8-43. West vertical shaft. Timbered dimensions are about  $8 \times 6$  feet. Reportedly 300 feet in depth. Lagging, sets, manway ladder, and bucket guides in place but irregularly constructed. No sets or lagging where rock walls are competent.

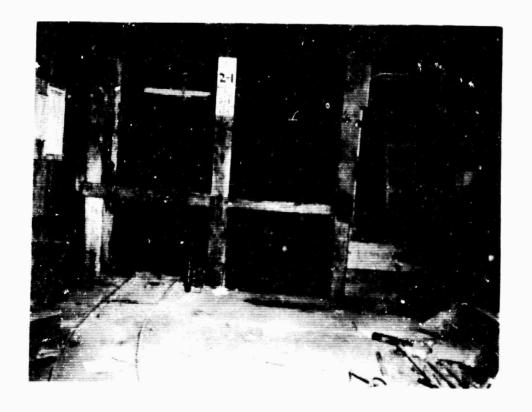
Photo No. 11-1-44. Shaft station on 100-foot level, elevation 5007 feet. Timbered dimensions are  $13 \times 6$  feet, cage compartment is  $5 \times 5$  feet, the other compartment cannot be used because of squeexing ground. The manway is usable,

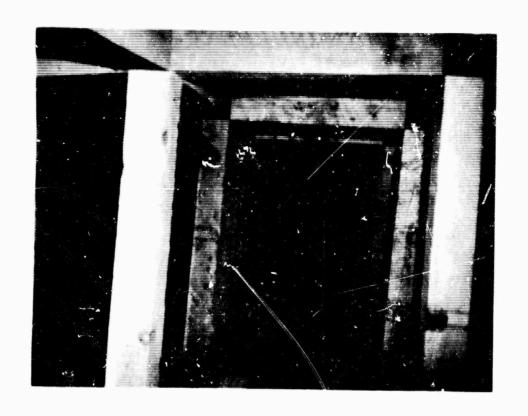
Photo No. 11-2-45. Lengthwise view of 250 stope two sets below the 100-foot level. This stope is square set on irregular 5 x 5-foot centers with 8 x 8-inch timbers. Some areas are supported by timber cribbing. Estimated stope dimensions are 100 feet in length and 25 to 75 feet in width. In vertical dimension the 250 stope extends for several levels. Some timber posts and caps in square sets have been crushed and squeezed by ground movement. The bearing of the stope is about north south.

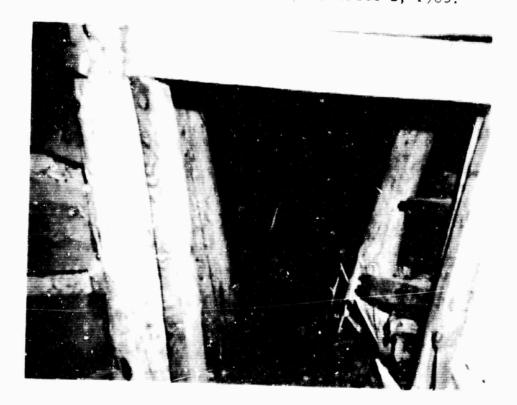
Photo 11-12-55. Preshot, October 2, 1963.

Photo No. 11-12-55. Row of broken 10-inch round timber posts on hanging wall of 74. A stope on 450-foot level. The bearing of this stope is about northeast.

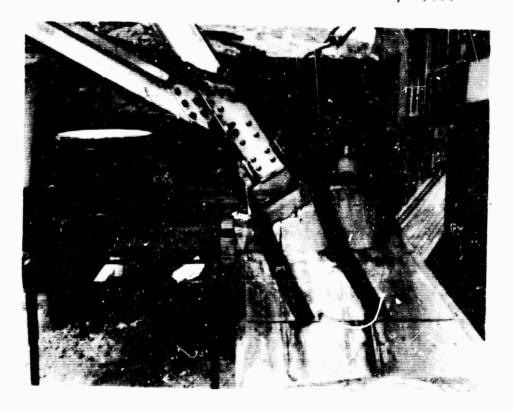
Photo 11-14-57. Preshot. October 2, 1963.

Photo No. 11-14-57. Subsidence by undermining from the 250 stope has caused separation between the steel leg and concrete pier of left rear post of headframe. Reference mark measured 6.05 inches separation both pre- and postshot. The  $1/4 \times 3$ -inch steel straps holding the headframe leg to the concrete pier do not form a rigid connection and the steel straps can be deflected by hand pressure.

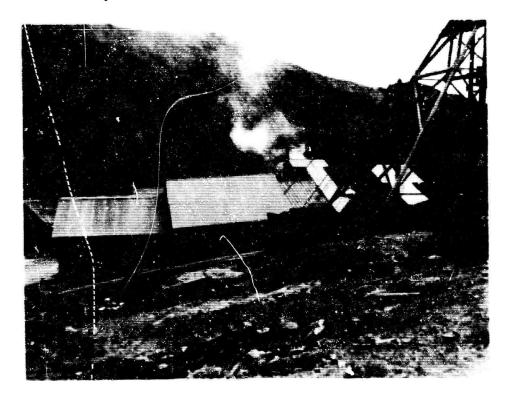
Photo 11-15-58. Preshot. October 2, 1963.

Photo No. 11-15-58. Subsidence by undermining from the 250 stope has caused a four degree northward tilt to hoist house. The concrete foundation for the hoisting equipment has a large crosswise crack immediately behind the main drum. The hoist consists of a cylindrical double drum electric powered system mounted on a steel frame.

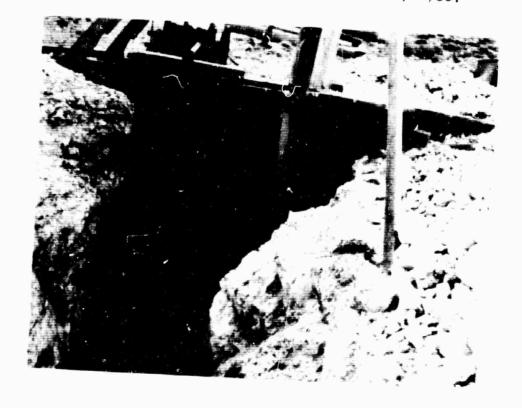
Photo 12-1-59. Preshot. October 2, 1963.

Photo No. 12-1-59. Vertical prospect shaft about 25 feet in depth with stope mined to surface around shaft. Timber prospect headframe with steel hand winch in place on surface. The shaft consists of four timber legs with a ladder in place. The stope contains two timber stulls.

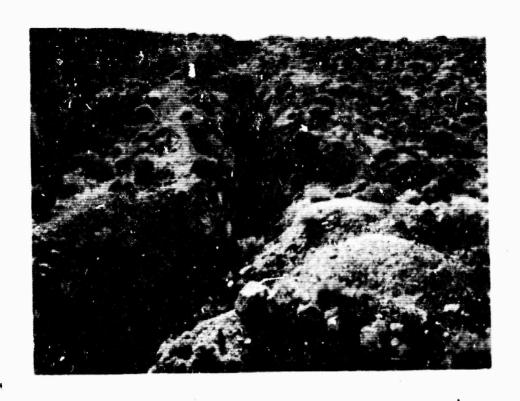
Photo 13-2-61. Preshot. October 2, 1963.

Photo No. 13-2-61. Open cut about 100 feet long, up to 15 feet deep, and of irregular width up to 6 feet. Two 6 x 6-inch timber stulls are used for support.

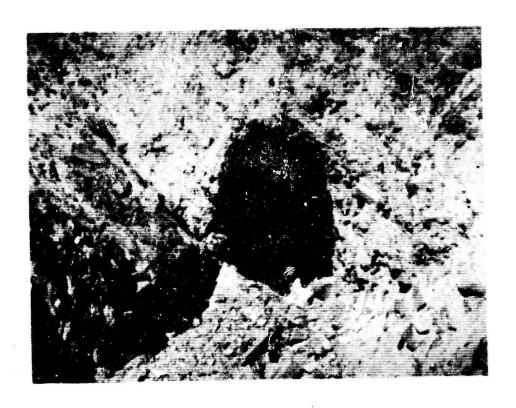
Photo 13-4-63. Preshot. October 2, 1963.

Photo No. 13-4-63. Entrance to west adit. Rock dimensions are about 7 feet wide, 6 feet high, and several hundred feet long. The rock is fractured and weakened above the adit portal. Some rock falls have previously occurred at the portal and along the adit. No support was used for this adit.

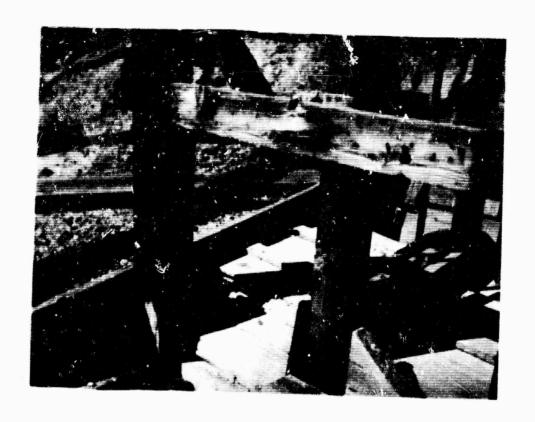
Photo 13-5-64. Preshot. October 2, 1963.

Photo No. 13-5-64. Entrance to east adit. Rock dimensions are about 6 x 3 feet and several hundred feet in length. Some rock falls have previously occurred at the portal and along the adit. No support was used for this adit. The portal has been driven it semi-consolidated alluvium.

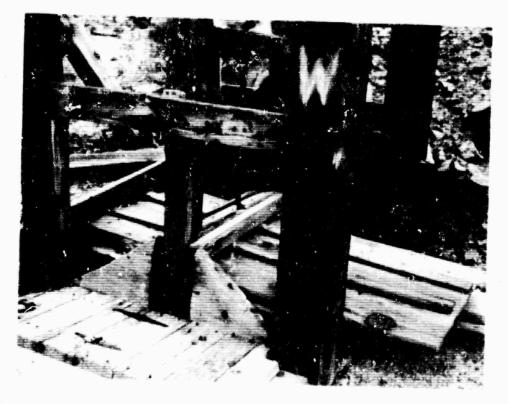
Photo 13-6-65. Preshot. October 2, 1963.

Photo No. 13-6-65. Collar of main vertical shaft. The timbered dimensions are 8 x 5 feet. The shaft is reportedly 150 feet deep. The cage compartment is blocked by timber planks. The manway is accessible with timber sets, lagging, cage guides, and ladder in place. No partition with manway.

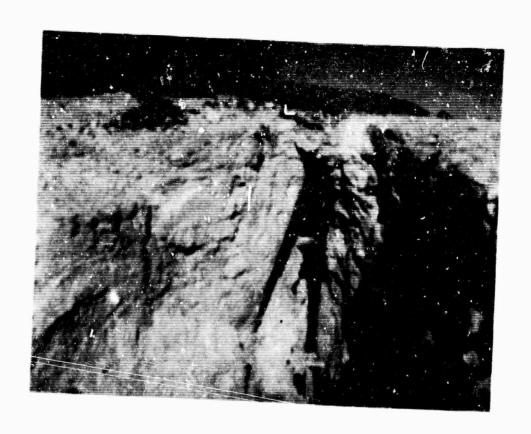
Photo 14-1-66. Postshot. October 31, 1963.

Photo No. 14-1-66. Nearly vertical open stope mined to the surface immediately to the south of the main shaft. Irregular width 3 to 8 feet, and 100 feet or more in length and depth. The trailer in the center background lies near the edge of the open stope. The trailer burned down from unknown causes on October 19, 1963.

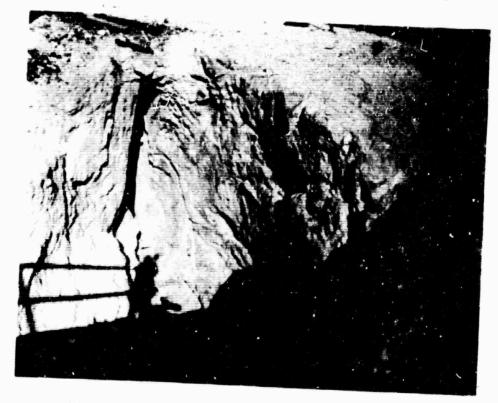
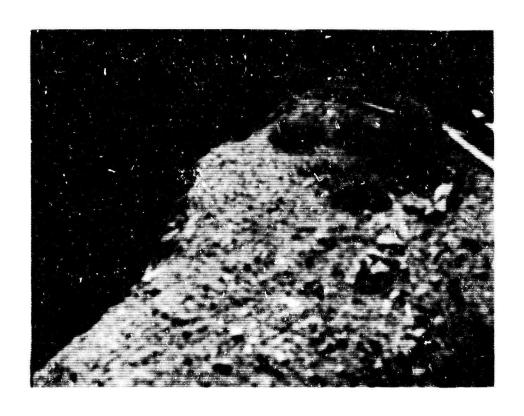
Photo 14-2-67. Preshot. October 3, 1963.

Photo No. 14-2-67. Nearly vertical open stope mined to the surface immediately to the north of the main shaft. Blacksmith shop in background lies on edge of open stope. Irregular width up to 15 feet, and 100 feet or more in length and depth. At the surface the stope has overhanging walls. No support was used other than occasional timber stulls.

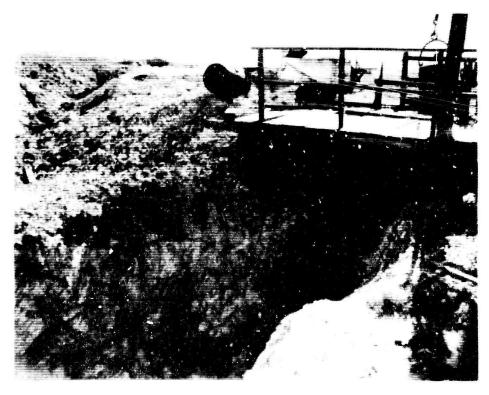
Photo 14-3-68. Preshot. October 3, 1963.

Photo No. 14-3-68. Open stope shown in previous photo and showing exposed collar set of main shaft in center background. Overhanging rock walls shown.

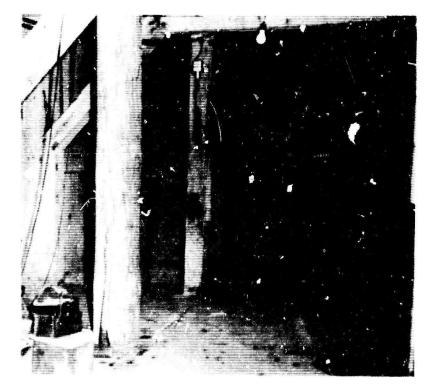
Photo 15-1-70. Preshot. October 10, 1963.

Photo No. 15-1-70. Shaft station on 350-foot level. The timbered dimensions of the shaft are 16 x 6 feet. The shaft is three-compartment, all timbered, with only one compartment in use for shaft rehabilitation work.

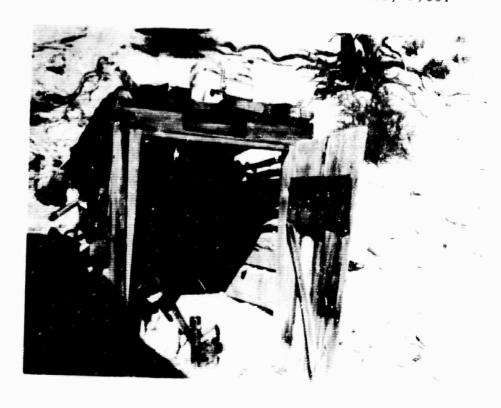
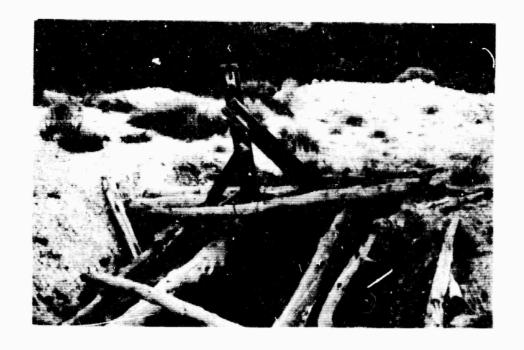
Photo 16-3-77. Preshot. October 22, 1963.

Photo No. 16-3-77. Portal of central adit. The adit bearing is about east-west and the length is about 400 feet. Five 6 x 6-inch timber sets on irregular 6 x 4-foot spacing with timber sprags for lagging are at the portal, otherwise the adit is unsupported. The adit dimensions are about 6 feet in height and 4 feet in width.

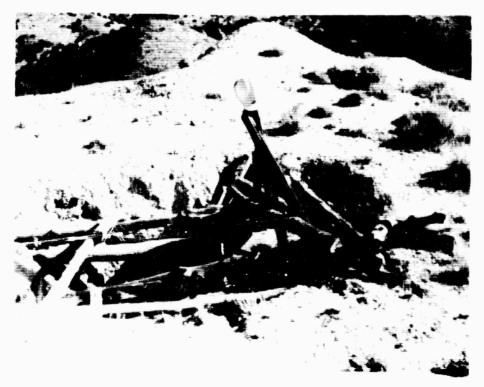
Photo 16-4-78. Preshot. October 22, 1963.

Photo No. 16-4-78. Surface view of main vertical shaft looking to southeast. Some uncut timber sprags are laid across the collar. No support was used in this shaft. The rock dimensions are about 5 x 5 feet. The shaft is caved and sealed with debris about 30 feet below the surface.
